# City of Lethbridge Heritage Inventory

## **City of Lethbridge Heritage Inventory Project Final Report**

## Draft Statements of Significance

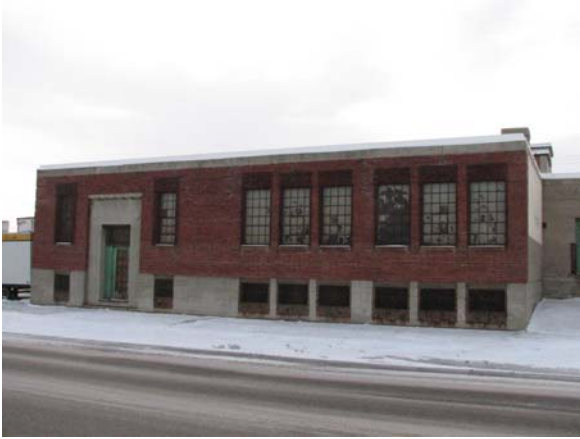
**Dominion Fruit Company Warehouse**

The one and one-half storey Dominion Fruit Company warehouse has a flat roof, brick cladding, multi-paned windows with cast stone sills, an exposed concrete foundation with basement windows, and an offset entrance with a decorative concrete door surround. It is located on a commercial avenue in the downtown core of Lethbridge.

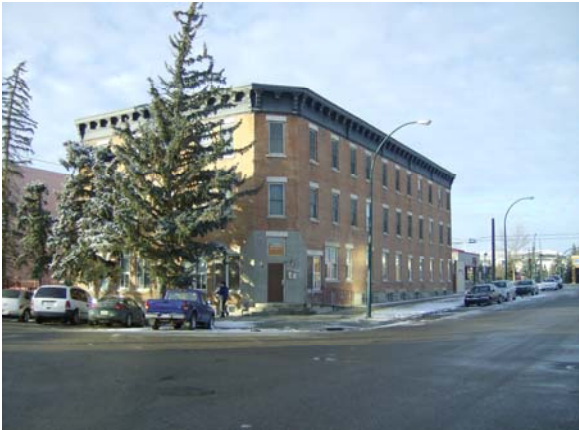
**Castle Apartments**

Known as the Castle Apartments, this three-storey building is clad in red brick and has a flat roof, a cornice with dentils and brackets, cast stone lintels and sills, and a chamfered entrance. It is located on three lots on the corner of a commercial avenue in Lethbridge’s downtown core.

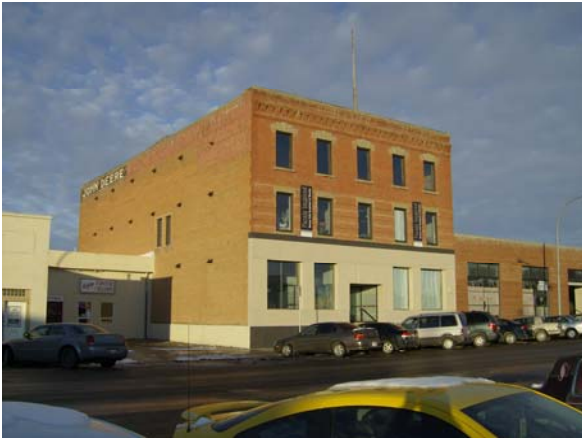
**John Deere Implements Building**

The brick three-storey John Deere Implements Building has a flat roof, a brick entablature with corbelled dentils, rusticated stone voussoirs above the third-storey windows, and a renovated storefront. It is located on two lots on a commercial avenue in the downtown core of Lethbridge.

- The flat roof
- The running bond brick cladding
- The corbelled brick cornice
- The rusticated stone voussoirs above the third storey windows
- The rectangular rusticated stone lintels above the second storey windows
- The rusticated stone sills on all windows
- The four decorative brick ribbon courses running between the second-storey windows on the front façade
- The painted wall signs on both side façades that read “JOHN DEERE” with a ghost image beside it reading “PLOW COMPANY FARM IMPLEMENTS”
- The corbelled brick chimney
- The beam pockets on the west wall
- The pattern, style and construction of all original window and door openings

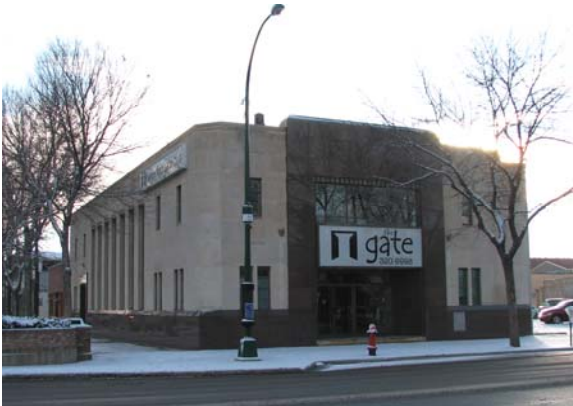
**Bank of Montreal / The Gate**

The two-storey Bank of Montreal building has a flat roof, precast concrete cladding, a polished stone frontispiece, and a granite plinth at street level. It is located on a corner lot on a commercial avenue in the downtown core of Lethbridge.

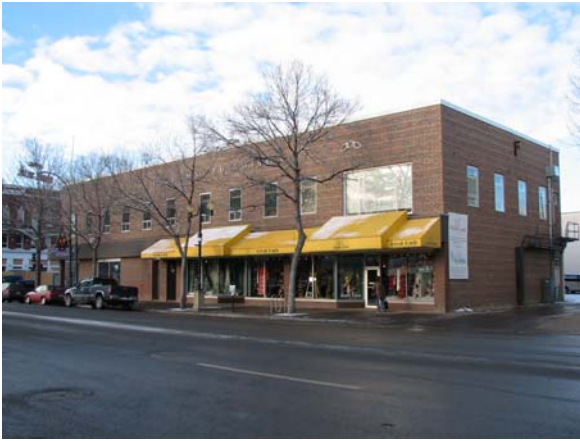
**I.O.O.F. Hall**

The two-storey I.O.O.F. Hall has a flat roof, brick cladding, and a plaque that reads “Independent Order of Odd Fellows Lethbridge Lodge No. 2 Instituted 1889”. It houses several shops on the main floor and the I.O.O.F. Lodge on the second floor. It is located on two lots on a commercial avenue in the downtown core of Lethbridge.

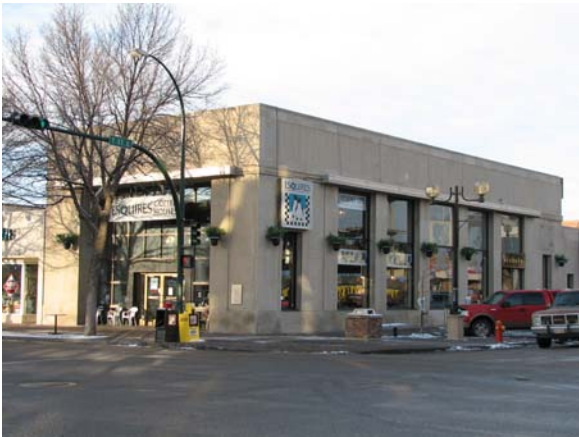
**621 4<sup>th</sup> Avenue South  
Former Royal Bank of Canada / Esquire's Coffee House**

This one-storey commercial building has a flat roof, grey Tyndall limestone cladding, and a large, recessed front entranceway with bronze double doors set in a full-height glass curtain wall. It is located on four lots on the corner of a commercial avenue in the downtown core of Lethbridge.

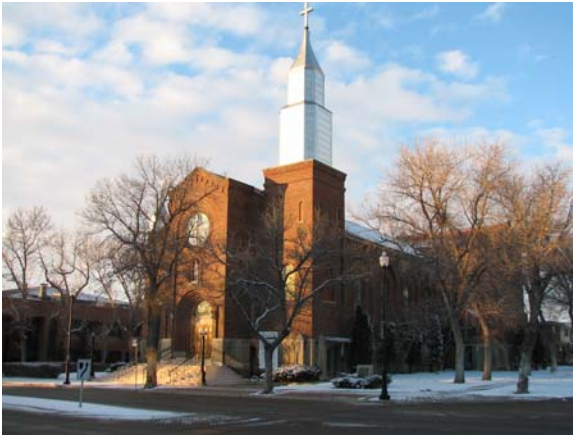
**St. Patrick's Roman Catholic Church**

The large one-storey brick-clad St. Patrick's Roman Catholic Church has a front-facing gable roof, a square tower with octagonal belfry and Latin cross spire, and a wheel window and a tabernacle that houses a statue of St. Patrick above the front façade entrance. The church is located on three lots on the corner of a commercial avenue in Lethbridge's downtown core.

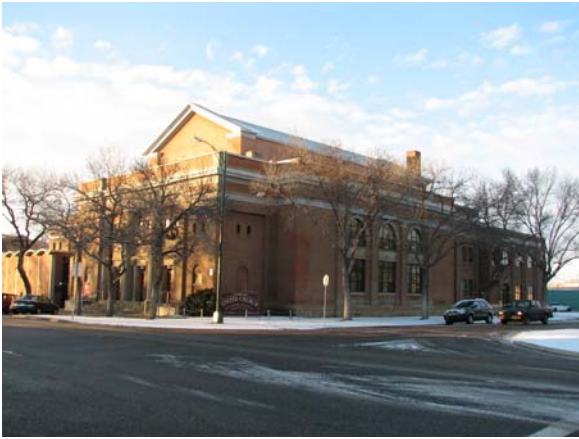
**Southminster United Church**

This large church has a flat roof with a high central gable, brick cladding, sandstone window surrounds and sills, a sandstone plinth, stringcourse and cornice, and a front entrance featuring four two-storey sandstone columns and three double-door entrances. It is located on a corner lot of a commercial avenue in the downtown core of Lethbridge.

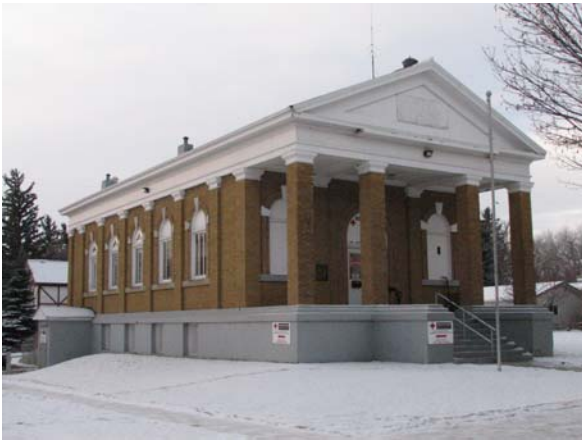
**1120 7<sup>th</sup> Avenue South  
Church of Jesus Christ of Latter Day Saints / Red Cross**

The Church of Jesus Christ of Latter Day Saints is a large one-storey brick building with a pediment gable roof, corbelled semi-circular arch window surrounds with cast stone keystones and skewbacks, pilasters with capitals on the side and rear façades, a portico supported by brick pillars with cast stone capitals, and a corbelled semi-circular brick door surround with a large keystone over the front entrance. It is located on a residential street in the city of Lethbridge.

- The pediment gable roof
- The inset portico supported by brick pillars with cast stone capitals
- The brick pilasters with cast stone capitals between the windows on the side façades
- The corbelled semi-circular brick window surrounds with cast stone sills, skewbacks and keystones
- The corbelled semi-circular brick door surround with a cast stone keystone
- The poured concrete foundation
- The pattern, style and construction of all original wooden windows

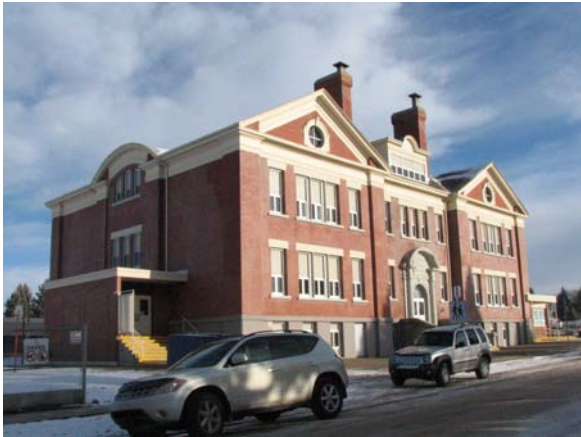
**Galbraith Elementary School**

The three-storey brick Galbraith Elementary School has a hipped roof with intersecting pediment gables at each corner, a central flat roof dormer flanked by two large brick chimneys, and a classically styled main entrance with columns and a hooded curved pediment. It is located on a large schoolyard on a residential street in Lethbridge.

- The hipped roof with intersecting pediment gables
- The brick cladding
- The classically-styled front entrance with Tuscan columns, a hooded curved pediment and a fanlight
- The moulded frieze
- The brick pilasters with cast stone capitals
- The oxeye windows in the pediment gable ends
- The eyebrow dormers at the centre of the side façades
- The flat roof dormers at the centre of the front and rear façades
- The large entablature
- The large symmetrical brick chimneys
- The concrete foundation imitating a plinth
- The concrete sills and lintels on all windows
- The cornerstone on the southwest corner of the building
- The pattern, style and construction of all original windows

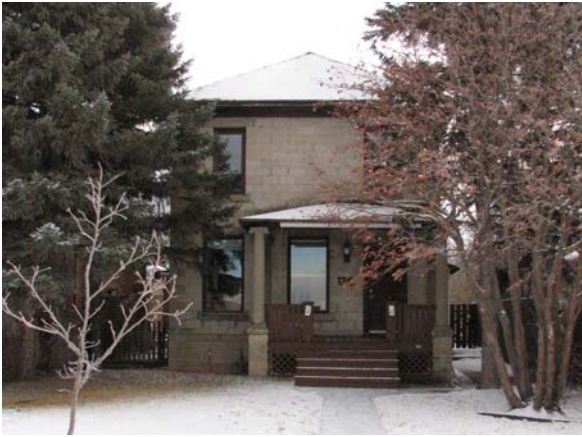
**Lanz Residence**

The two-storey Lanz Residence is a concrete block foursquare with a hipped roof and an open front porch with four Ionic concrete columns. It is located on a residential street in Lethbridge.

- The hipped roof
- The concrete block construction
- The cast stone lintels and sills
- The rusticated concrete block foundation
- The Ionic columns atop rusticated concrete block piers supporting the hipped roof on the front porch
- The brick chimney
- The pattern, style and construction of all original window and door openings

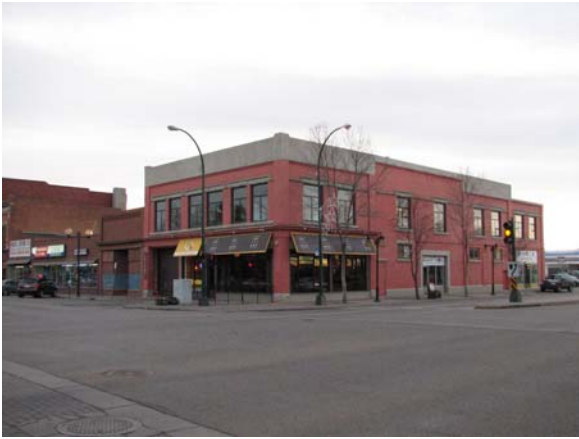
**Hudson's Bay / Trianon Ballroom Building**

The two-storey Hudson's Bay building has a flat roof, a pressed metal cornice between the first and second storeys, a stucco-finished parapet, and painted brick cladding. It is located on a corner lot on a commercial street in downtown Lethbridge.

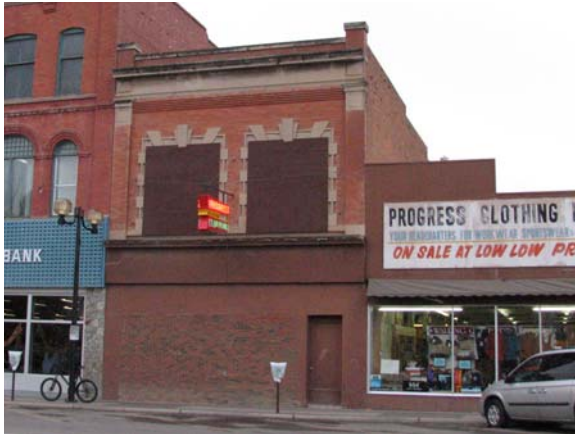
**Begin Block**

The two-storey Begin Block has a flat roof, red brick cladding, second-storey windows with Gibbs surrounds, two brick pilasters on the front façade, and a parapet with a cast stone cornice. It is located on a commercial street in the downtown core of Lethbridge.

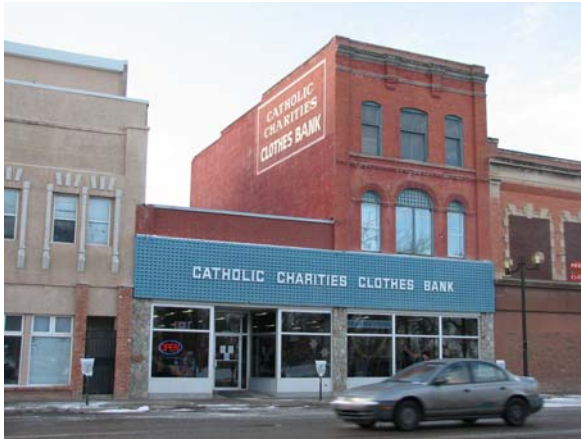
**Bentley Block**

The three-storey brick-clad Bentley Block has a flat roof, a flat parapet with a cast stone cornice and stepped sides, three segmental arch windows on the third storey, and three large semicircular arched windows on the second storey. It is located on a commercial street in the downtown core of Lethbridge.

- The flat roof
- The running bond brick cladding on the front façade, common bond brick cladding on the side façades
- The flat parapet with a moulded cast stone cornice
- The corbelled brick stringcourse between the second and third storeys
- The continuous, shared cast stone sill below all third-storey windows
- The brick segmental arch with brick voussoirs above the third storey windows
- The three semi-circular arched windows with corbelled brick voussoirs on the second storey
- The two short, decorative brick pilasters above the third-storey windows
- The pattern, style and construction of all original window openings, especially the three semi-circular windows on the second storey

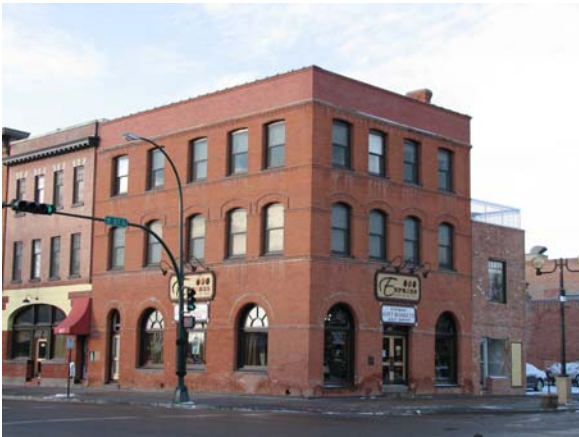
**222 5<sup>th</sup> Street South  
Union Bank of Canada / Express Coffee & Tea**

The three-storey Union Bank of Canada building has a flat roof, brick cladding, and rounded arch window openings, the most prominent of which are on the first floor. It is located on a corner lot of a commercial street in the downtown core of Lethbridge.

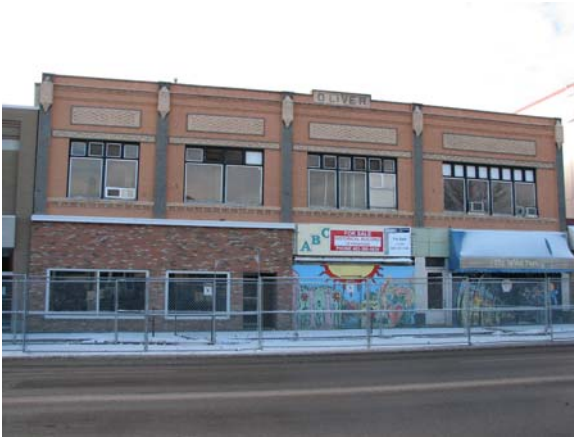
**Oliver Block**

The two-storey Oliver Block has a flat roof, brick cladding, four bays on the second storey articulated by brick pilasters, and a brick inscription on the parapet that reads “OLIVER”. It is located on two lots on a commercial street in the downtown core of Lethbridge.

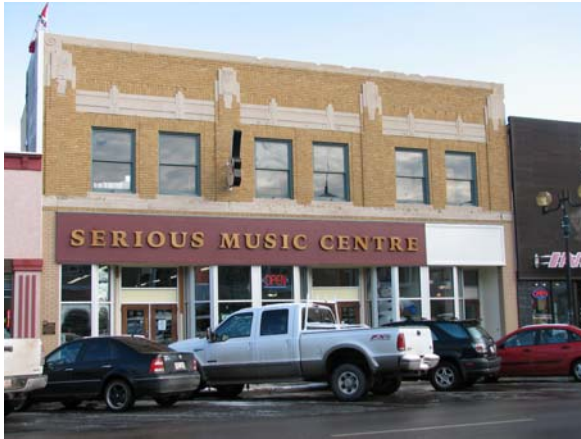
**Kresge Building**

The two-storey brick Kresge Building has a flat roof with a cast stone capped parapet, decorative cast stone stringcourses, and decorative brick pilasters with moulded art deco cast stone caps on the second storey. It is located on a commercial street in the downtown core of Lethbridge.

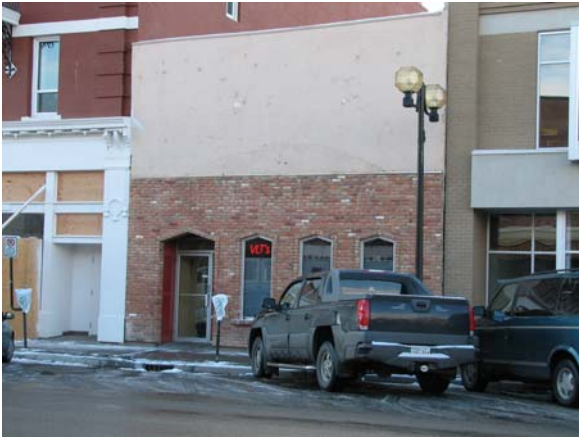
**Lyceum Theatre / Starland Theatre**

The one-storey Lyceum Theatre has a flat roof with a stucco parapet, brick cladding on the storefront, and triangular window and door openings. It is located on a commercial street in the downtown core of Lethbridge.

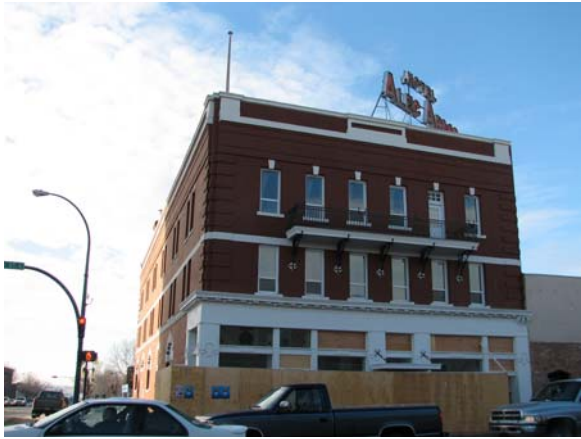
**Alec Arms Hotel**

The three-storey Alec Arms Hotel has a flat roof, red brick cladding, ribbon bands above and below the second storey windows, and corbelled decorative brickwork at the corners. It is located on two lots at the corner of a commercial street in the downtown core of Lethbridge.

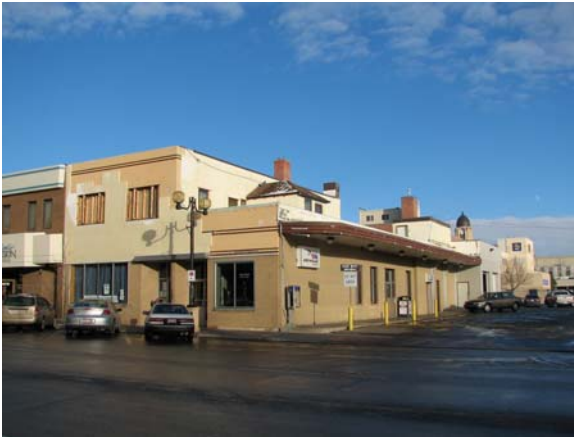
**Greyhound Bus Depot**

The one and two-storey Greyhound Bus Depot has a flat roof, a brick and stucco finish, an awning with curved corners on the building's side, two recessed ribbon courses above the second storey windows, and a recessed main entrance. It is located on a commercial street in the downtown core of Lethbridge.

- The flat roof
- The white stucco finish with black trim
- The awning with curved corners on the first storey along the side of the building
- The solid brackets beneath the awning
- The two recessed ribbon courses above the second-storey windows
- The recessed main entrance
- The brick chimney
- The pattern, style and construction of all original window and door openings

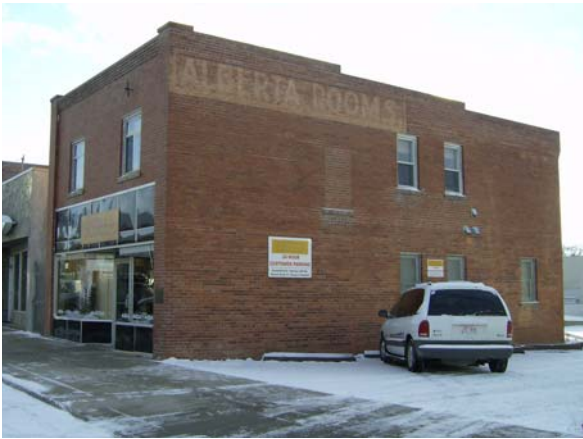
**110 8<sup>th</sup> Street South  
Vendome Hotel / Alberta Rooms / Roloff Beny Studio**

The two-storey Vendome Hotel has a flat roof with a corbelled cornice, a flat parapet with stepped side façades, two brick pilasters on the front façade, and red brick cladding. It is located on a commercial street in the downtown core of Lethbridge.

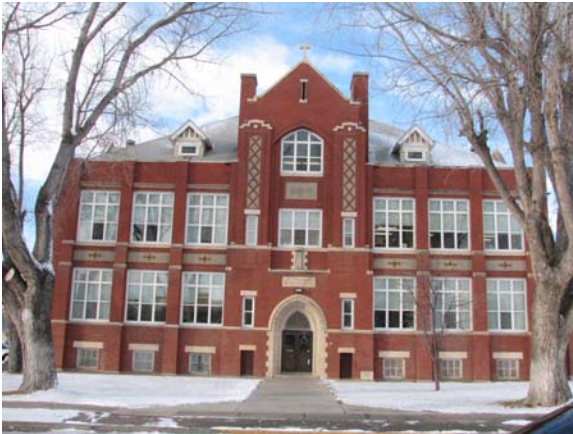
**St. Basil's Education Centre**

The two and one-half storey brick school known as St. Basil's Education Centre has a hipped roof, large cross gables with parapets, two small gable roof dormers, and a central front entrance with a pointed arch transom window. It is located in a large schoolyard with several mature trees on a residential street in Lethbridge.

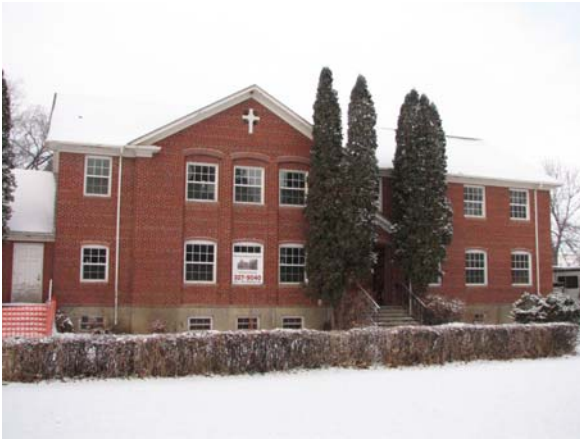
**St. Aloysius Convent**

St. Aloysius Convent is a two-storey red brick building with an intersecting gable roof. It is located on a large landscaped lot on a residential street in Lethbridge.

- The side-facing gable roof
- The common bond red brick cladding
- The intersecting front-facing gable roof with returned eaves and a concrete Celtic cross in the gable end
- The six recessed windows beneath the intersecting front-facing gable roof with three brick pilasters between them
- The moulded frieze beneath the roof
- The arched brick voussoirs over the first-storey windows and the three second-storey windows beneath the intersecting front-facing gable
- The offset main entrance with a front-facing gable roof
- The brick chimney
- The smooth concrete foundation
- The pattern, style and construction of all original windows

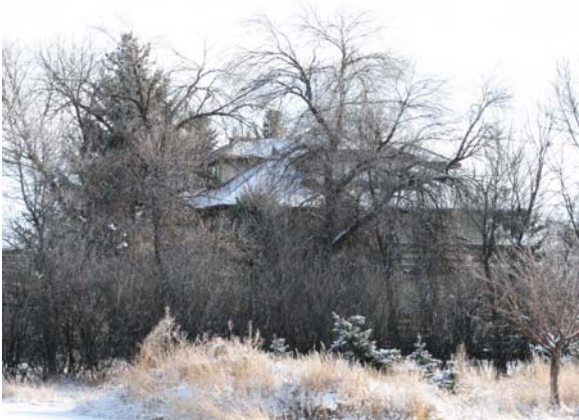
**Parry Farm**

This two and one-half storey farmhouse has a hipped roof, double concrete walls with a stucco finish, three hipped roof dormers, and a concrete chimney. It is located on approximately forty acres on the south half of Legal Sub-divisions 5 and 6 of Section 22, Township 8, Range 21, West of the 4<sup>th</sup> Meridian.

- The double concrete walls with an airspace between them
- The pattern, style and construction of all of the original door and window openings

May require intervention to meet Provincial requirements prior to designation. Any interventions should be in accordance with the *Standards and Guidelines for the Conservation of Historic Places in Canada*.
